C & A LAKE DAM
AUDRAIN COUNTY, MISSOURI
MO. 10105

PHASE I INSPECTION REPORT
NATIONAL DAM SAFETY PROGRAM

DECEMBER 1979

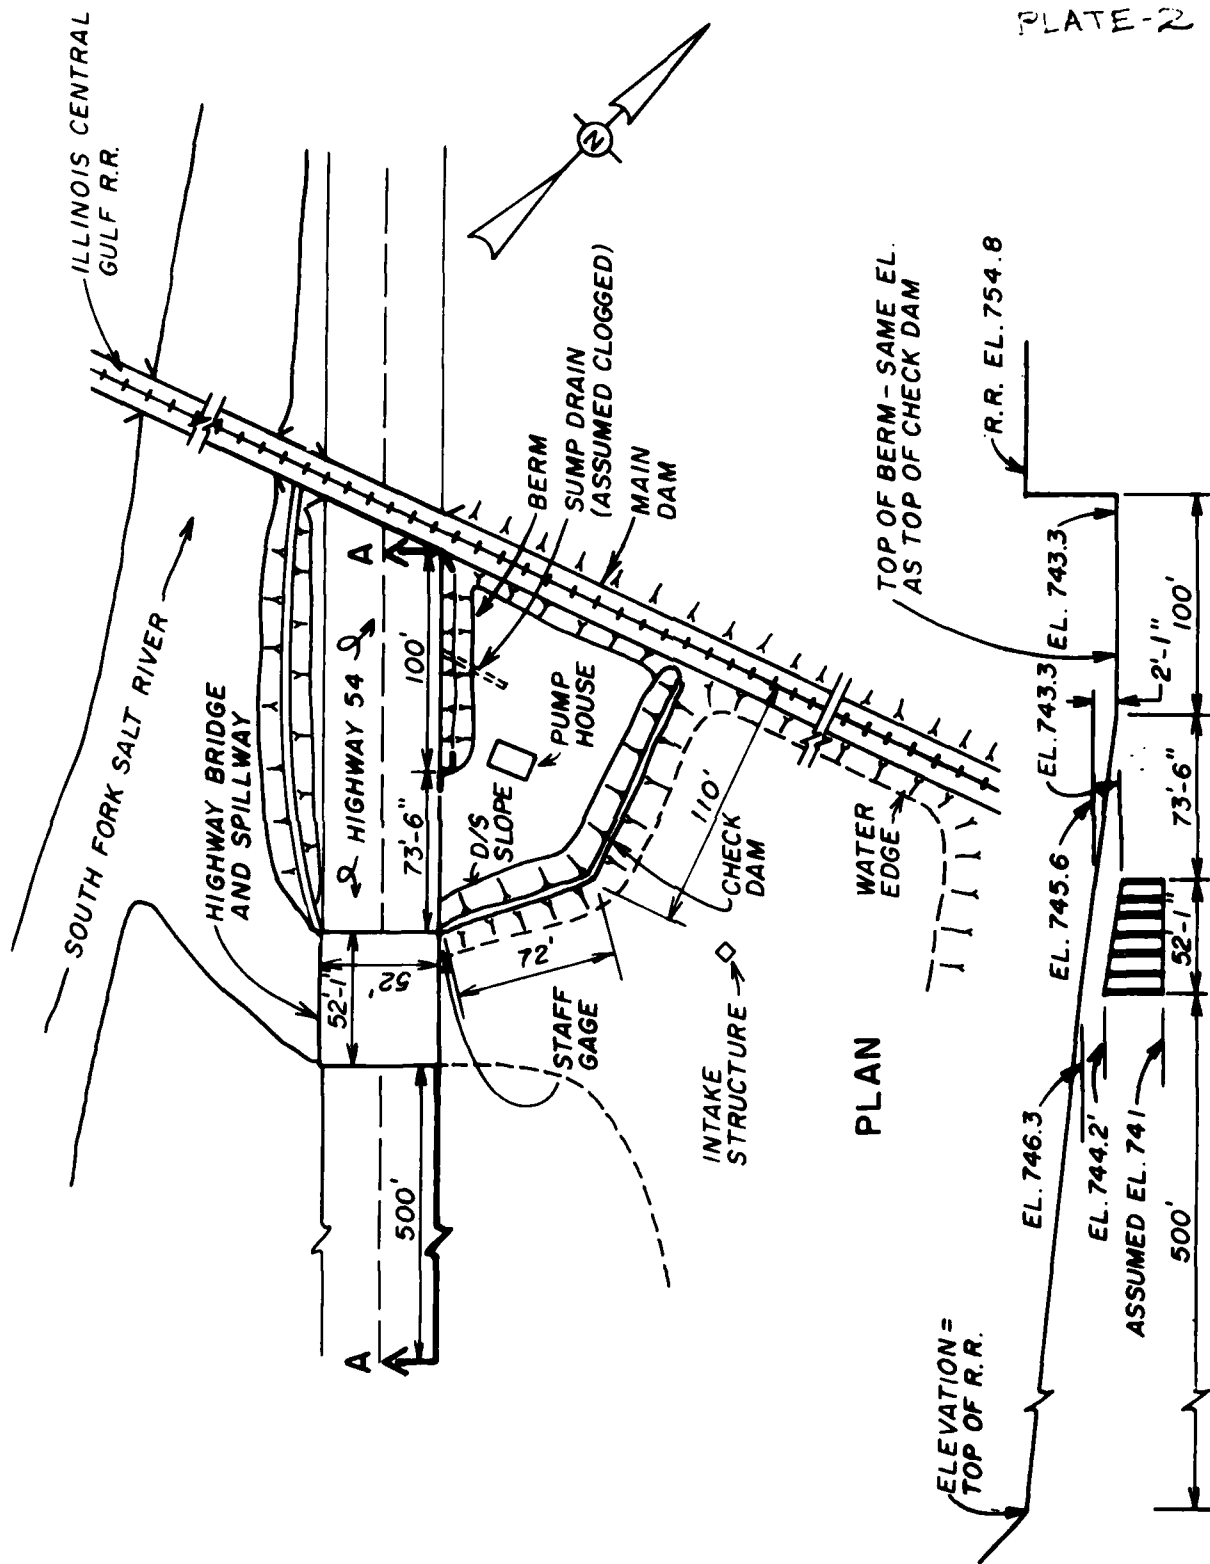
C & A LAKE DAM (MO. 10105)
PLAN & ELEVATION

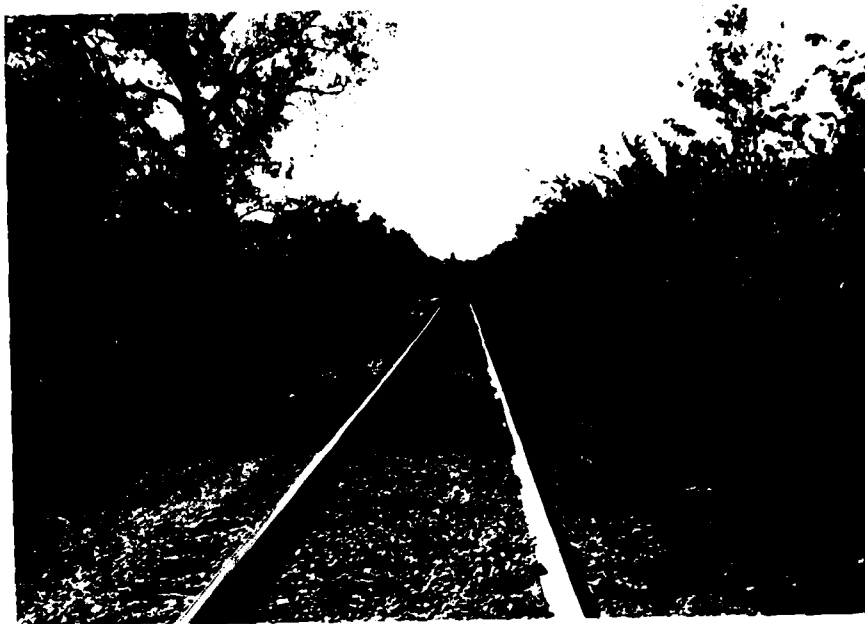
protected by cinders. No evidence of settlement was observed along the crest. No cracks were observed.

Photo D1 - View of the crest.
